Passenger car tire road wheel removal codes

By Larry Evans and Walter Waddell
Tire Technology Training Co.

TECHNICAL NOTEBOOK

Executive summary

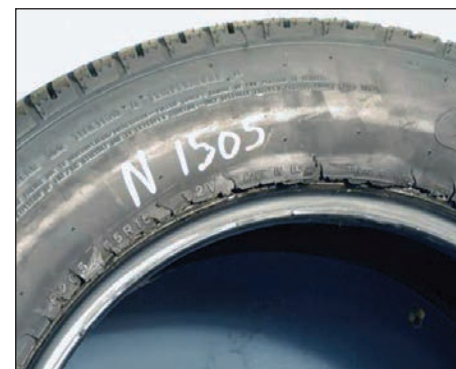
Fig. 2: Photograph of a tire displaying bead turnout cracking = BdTuCr.

passenger car radial tires. In approximate order of increasing severity they are: bead damage (BdD), which can be cracks, tears or separations on the bead toe or heel areas that extend to ply material and can be caused by mounting or dismounting the tire; bead ripped (BdRi), which can be caused by a breakdown of bonding between components in the bead area; bead turnup cracking (BdTuCr), which can be cracks in the rubber in the lower sidewall area that can extend into the ply material (Fig. 2); and bead turnup rupture (BdTuR) of the body ply cords with radial cracking, which can lead to rapid air loss in the tire (Fig. 3).

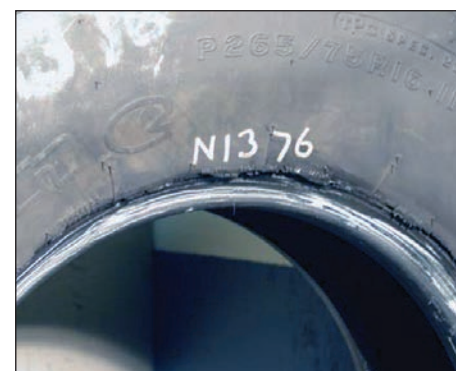
Fig. 3: Photograph of a tire displaying a bead turnout rupture = BdTuR.

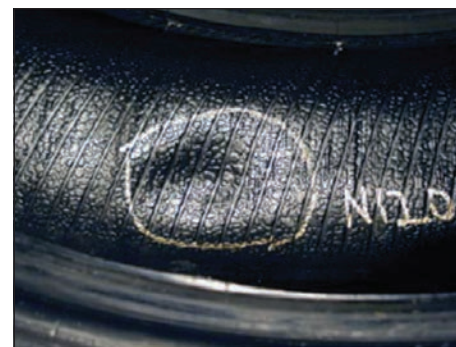
Fig. 4: Photograph of a tire displaying an innerliner separation = ILS.

For the tire innerliner region, four removal codes have been established. In approximate order of increasing severity they are: innerliner separation (ILS), which can be a parting of the innerliner from cord material in the carcass and can range from a small blister or bubble (Fig. 4) or can be larger separations with or without air loss; innerliner split (ILSplit), which can be cracking which can result in air loss (Fig. 5), or openings at the innerliner splice, or openings which can be caused by carcass cord material penetrating (striking through) into the innerliner and can lead to air loss; and innerliner damage (ILD) and innerliner failure (ILF), which can lead to rapid air loss from the tire.

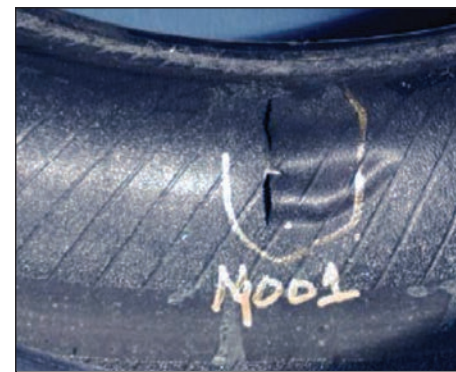
Fig. 5: Photograph of a tire displaying an innerliner split = ILSplit.

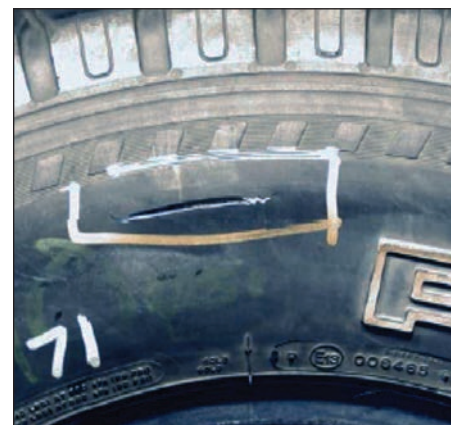
Fig. 6: Photograph of a tire displaying a sidewall crack = SwCr.

For the tire sidewall region, four removal codes have been established: blister or bubble on the sidewall (SwBlister); sidewall cracking (SwCr), which can be a crack typically circumferentially in the mid (Fig. 6) to upper sidewall area; sidewall rupture (SwR), which can be the breaking away of pieces of the sidewall with or without loss of air; and sidewall rupture with delamination (SwR+DI), which can be the separation or peeling of sidewall pieces (Fig. 7).

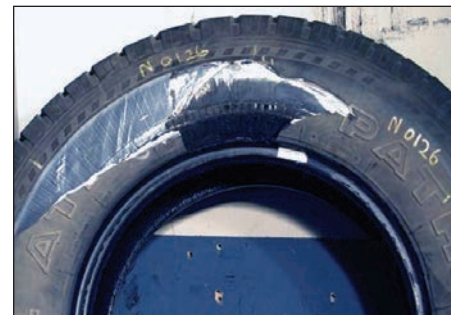
Fig. 7: Photograph of a tire displaying a sidewall rupture with delamination = SwR+DI.

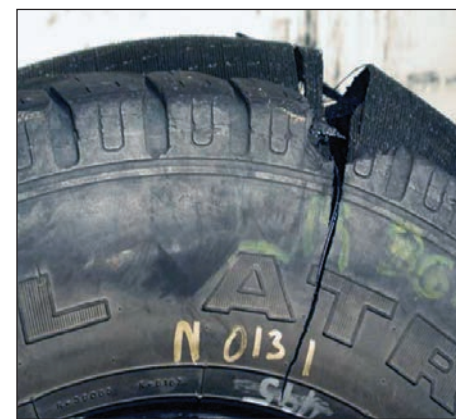
Fig. 8: Photograph of a tire displaying a carcass rupture = CaR.

code for carcass rupture (CaR) has been established (Fig. 8), and two removal codes for ply coat delamination at the interface with the sidewall (PCD-I), (Fig. 9) and to the tire cords (PCD-TC) have been established.

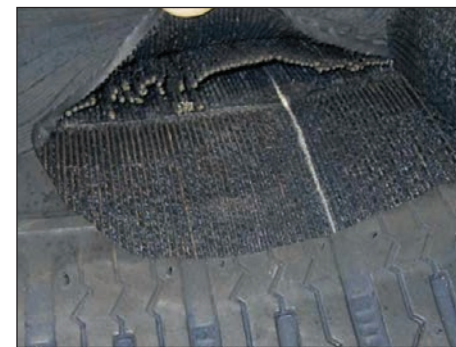
Fig. 9: Photograph of a tire displaying ply coat delamination at the interface of the sidewall = PCD-I.

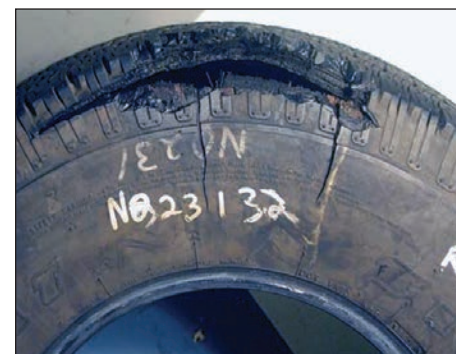
Fig. 10: Photograph of a tire displaying shoulder rupture = ShR.

cally circumferential, in the upper sidewall or tread shoulder that extends down to the ply material; shoulder rupture (ShR), which can be a circumferential separation through the innerliner and the carcass plies in tread shoulder region which can lead to rapid air loss (Fig. 10); tread shoulder cracking (TShCr); tread shoulder pocket cracking (TShPoCr) and tread shoulder chunking (TShC), which can both be the breaking away of pieces of the tread at the shoulder region (Fig. 11); and

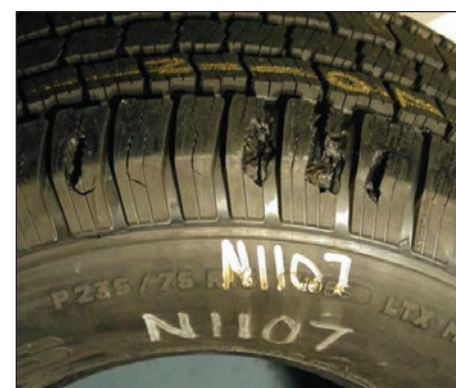
Fig. 11: Photograph of a tire displaying tread shoulder chunking = TShC.

codes have been established for tread groove cracking (TGCr) (Fig. 19); tread chunking (TC), which can be the breaking away of pieces of the tread (Fig. 11); and tread lug chunking (TLC), which can be a localized, partial-depth chunk-

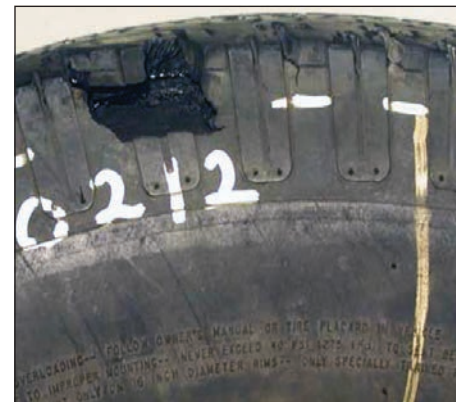
Fig. 12: Photograph of a tire displaying tread shoulder chunking with belts exposed = TSh+BE. Tread shoulder cracking is also visible = TShCr.

tread shoulder chunking with belts exposed (TShC+BE) (Fig. 12).

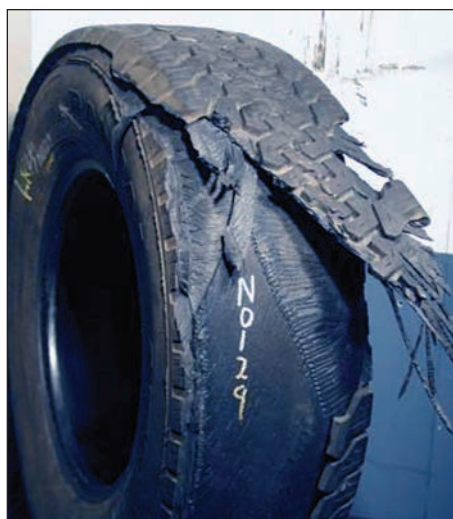
Fig. 17: Photograph of a tire displaying partial tread to belt No. 2 detachment = PT+B2D.

Removal codes have been established representing different possible types of failures in the belt region. They include: belt edge exposed (BEE) (Fig. 13); belt edge loosened (BEL) (Fig. 14); belt edge separation (BES) (Fig. 15); belt No. 1 to carcass detachment (B1P1D) (Fig. 16); belt No. 1 to belt No. 2 separation (BBS); partial tread and belt No. 2 detachment (PT+B2D) (see Fig. 17); and complete tread and belt No. 2 detachment (CT+B2D) (Fig. 18).

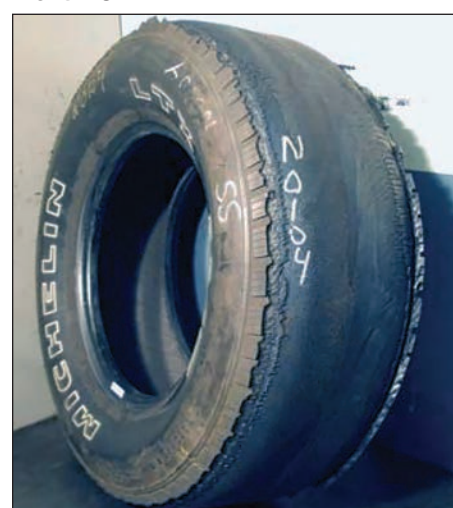
Fig. 18: Photograph of a tire displaying complete tread to belt No. 2 detachment = CT+B2D.

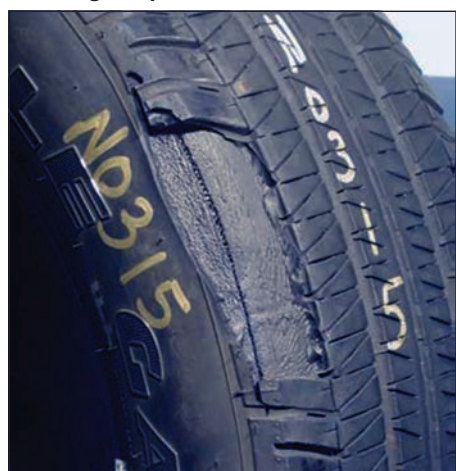
Fig. 13: Photograph of a tire displaying belt edge exposed = BEE.

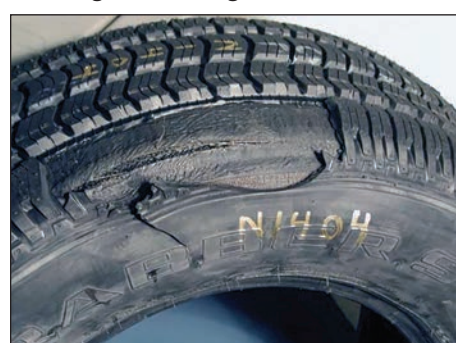
Fig. 14: Photograph of a tire displaying belt edge loosening = BEL.

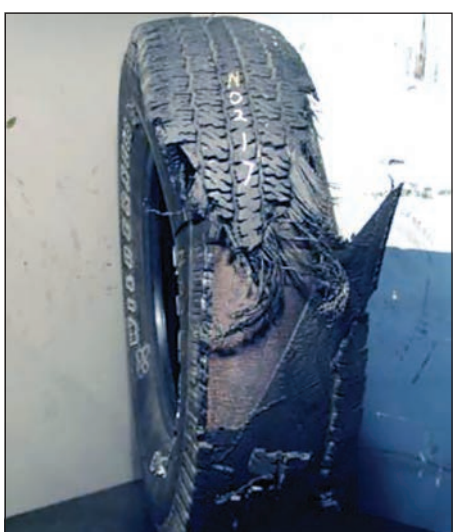
Fig. 16: Photograph displaying belt No. 1 to carcass detachment = B1P1D.
